A CASE STUDY IN AVALANCHE RISK TOLERANCE IN TWO TRANSMISSION LINES: 1) COLORADO, USA AND 2) EASTERN ICELAND

Art Mears, P.E.¹ and Chris Wilbur P.E.².

ABSTRACT: Avalanche risk tolerance in two transmission lines is compared in this paper. A 115kV line in southwestern Colorado supplies electrical power to the Telluride Ski Area and surrounding populations. Forty-five structures and some adjacent conductor spans are exposed to avalanches. Three categories of exposure were identified: exposure level "A" (annual probability of a destructive encounter is 0.05); level "B" (annual probability is 0.02); level "C" (annual probability is 0.005). Frequency was estimated from history and vegetation indicators. Dynamics were quantified by applying avalanche-dynamics models. A smaller 69kV line also delivers electricity to the area; however power is not sufficient to run all facilities simultaneously. The owner of the 115kV line protected the 10 Level "A" and the 20 level "B" structures.

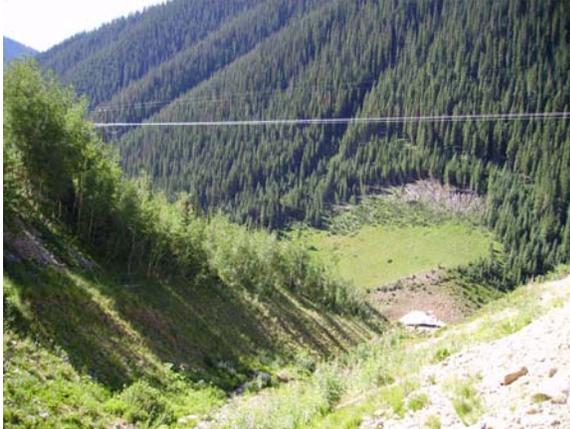
Figure 1. Typical avalanche terrain and impact areas.

Figure 1 shows the impact of an avalanche on the opposite side of a

narrow valley along the line. This is typical of the avalanche terrain. The smaller area of damage on the opposite valley side was caused by this 2005 avalanche that had an estimated return period of about 30 years.

The flowing snow missed a pole (beyond left of picture) by 3m and subjected the conductors to powder blast, but line failure did not occur at this location. The larger area surrounding the recent impact was caused by a much more energetic avalanche with an estimated return period of about 100 years, judging from tree ages. This larger avalanche occurred prior to line construction. If the 100-year avalanche were to occur again it would probably subject conductors and one structure to significant avalanche impact forces. Structural protection was recommended at this location.

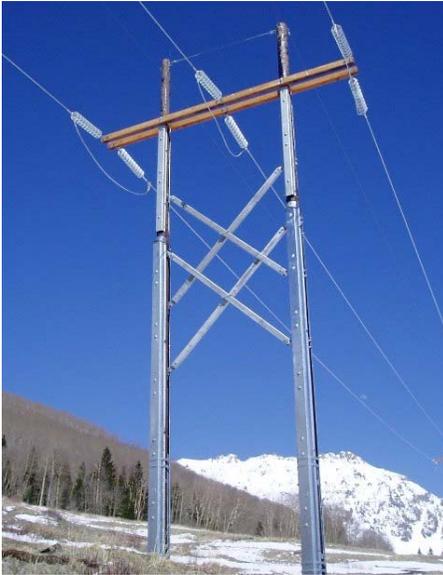
Figure 3. Structure protection.

The bending moments were calculated by a structural engineer based on structure-specific dynamic loads imparted by the avalanche. The loads transferred to the towers are resisted by the steel sleeve and transfer of stresses to the adjacent pole. Powder-avalanche pressures on conductors and the increased bending moments resulting were also considered in the overall stability analysis.

The owner of the line provided mitigation by stiffening the towers on all level A and level B exposed structures by placing steel sleeves around the exposed wood poles up to an assumed impact height. An example of a steel sleeve is shown in Figure 3. The impact heights and forces were estimated by applying the Swiss avalanche dynamics model AVAL-1D. In addition, steel

cross-braces between poles were added to structurally couple the stiffened structures.

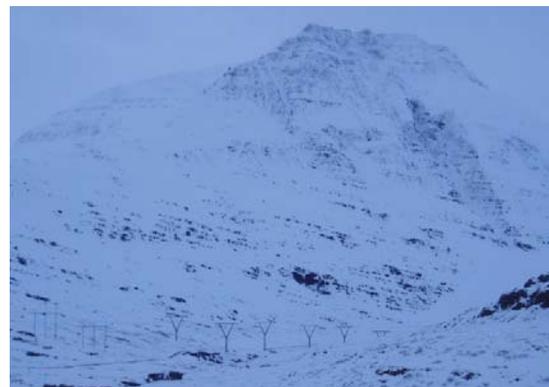
Figure 4. Typical avalanche terrain.

A 420kV line in northeastern Iceland (Jonsson, 2008) is the only source of electrical power to a large aluminum smelter. This line passes through approximately 50km of glaciated volcanic terrain in eastern Iceland. Lack of forest, strong winds, steep terrain and a high latitude maritime climate characterize avalanche conditions. The line elevation is between 20 and 620 meters above sea level. The design magnitude avalanche is associated with heavy precipitation and strong winds. Figure 4 shows typical avalanche terrain.

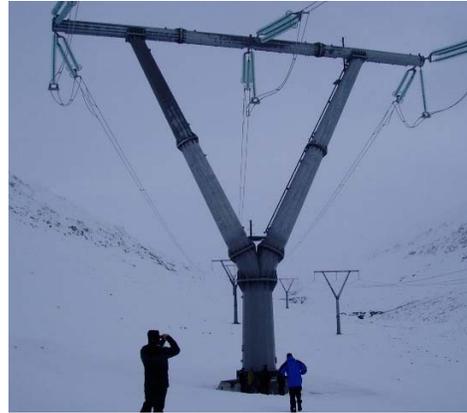
Figure 5. “Y” type Single Pole Tower

The Iceland transmission line has 82 structures that are exposed to some avalanche impact. Figure 5 shows the “Y” type single pole towers used in Iceland. Some of the conductors are exposed to low density portion of the upper avalanche flow, but these loads are relatively small due to the heights of the conductors. The annual probability, P , or return period $T (= 1/P)$ was calculated based on an analysis 50 years of weather data from four weather stations within the region. Statistical runout models and dynamic models were used to calculate design loads. Vegetative indicators are generally not available in Iceland. The calculated exposure level for failure of both lines was, $P = 6.5 \times 10^{-4}$ ($T \approx 1500$ years).
