A CASE STUDY IN AVALANCHE RISK TOLERANCE IN TWO TRANSMISSION LINES: 1) COLORADO, USA AND 2) EASTERN ICELAND

Art Mears, P.E.¹ and Chris Wilbur P.E.².

ABSTRACT: Avalanche risk tolerance in two transmission lines is compared in this paper. A 115kV line in southwestern Colorado supplies electrical power to the Telluride Ski Area and surrounding populations. Forty-five structures and some adjacent conductor spans are exposed to avalanches. Three categories of exposure were identified: exposure level "A" (annual probability of a destructive encounter is 0.05); level "B" (annual probability is 0.02); level "C" (annual probability is 0.005). Frequency was estimated from history and vegetation indicators. Dynamics were quantified by applying avalanche-dynamics models. A smaller 69kV line also delivers electricity to the area; however power is not sufficient to run all facilities simultaneously. The owner of the 115kV line protected the 10 Level "A" and the 20 level "B" structures.

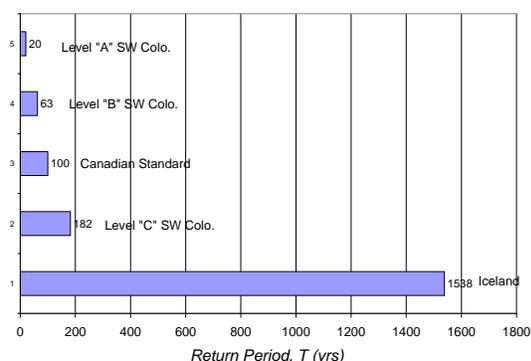
Figure 6 Return Periods for Various Levels of Risk for Transmission Lines.

Figure 6 shows average return periods associated with acceptable levels of risk for the SW Colorado transmission line

and the Iceland 420 kV line, along with the Canadian standard. The Colorado example is from a recreational area and has a redundant source of electrical power. Essential services may be maintained in case of failure in the 115kV line. In Iceland, the aluminum smelter is supplied by the 420kV line. Failure of the line over a period of more than a few hours would result in failure of the smelter and a loss of approximately \$US 1 billion. This is an unacceptable monetary loss.
