A CASE STUDY IN AVALANCHE RISK TOLERANCE IN TWO TRANSMISSION LINES: 1) COLORADO, USA AND 2) EASTERN ICELAND

Art Mears, P.E.¹ and Chris Wilbur P.E.².

ABSTRACT: Avalanche risk tolerance in two transmission lines is compared in this paper. A 115kV line in southwestern Colorado supplies electrical power to the Telluride Ski Area and surrounding populations. Forty-five structures and some adjacent conductor spans are exposed to avalanches. Three categories of exposure were identified: exposure level "A" (annual probability of a destructive encounter is 0.05); level "B" (annual probability is 0.02); level "C" (annual probability is 0.005). Frequency was estimated from history and vegetation indicators. Dynamics were quantified by applying avalanche-dynamics models. A smaller 69kV line also delivers electricity to the area; however power is not sufficient to run all facilities simultaneously. The owner of the 115kV line protected the 10 Level "A" and the 20 level "B" structures.

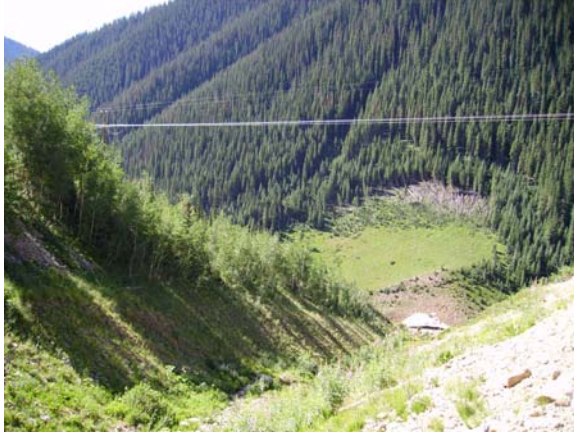
narrow valley along the line. This is typical of the avalanche terrain. The smaller area of damage on the opposite valley side was caused by this 2005 avalanche that had an estimated return period of about 30 years.

Figure 1. Typical avalanche terrain and impact areas.

The flowing snow missed a pole (beyond left of picture) by 3m and subjected the conductors to powder blast, but line failure did not occur at this location. The larger area surrounding the recent impact was caused by a much more energetic avalanche with an estimated return period of about 100 years, judging from tree ages. This larger avalanche occurred prior to line construction. If the 100-year avalanche were to occur again it would probably subject conductors and one structure to significant avalanche impact forces. Structural protection was recommended at this location.

Figure 1 shows the impact of an avalanche on the opposite side of a

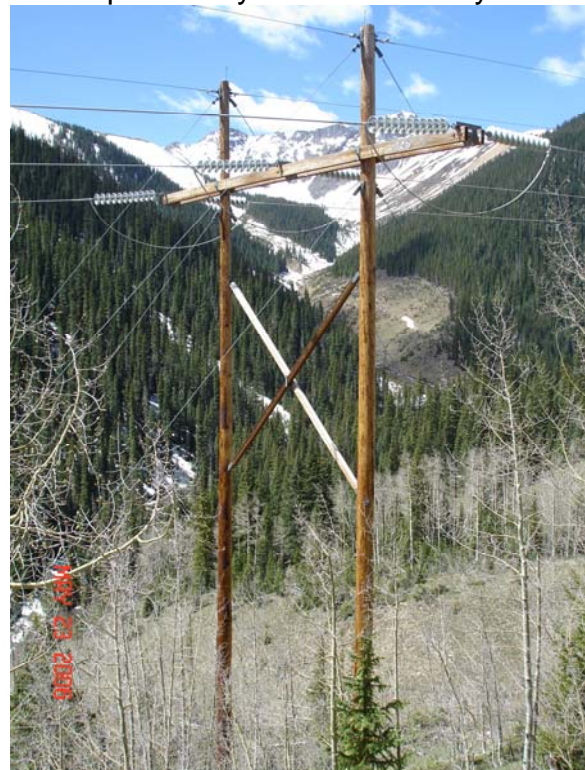
Figure 2. Structure prior to protection.

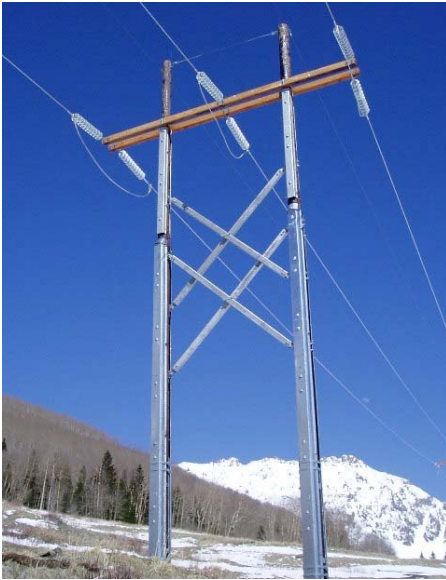
cross-braces between poles were added to structurally couple the stiffened structures.

Figure 3. Structure protection.

The bending moments were calculated by a structural engineer based on structure-specific dynamic loads imparted by the avalanche. The loads transferred to the towers are resisted by the steel sleeve and transfer of stresses to the adjacent pole. Powder-avalanche pressures on conductors and the increased bending moments resulting were also considered in the overall stability analysis.

The owner of the line provided mitigation by stiffening the towers on all level A and level B exposed structures by placing steel sleeves around the exposed wood poles up to an assumed impact height. An example of a steel sleeve is shown in Figure 3. The impact heights and forces were estimated by applying the Swiss avalanche dynamics model AVAL-1D. In addition, steel

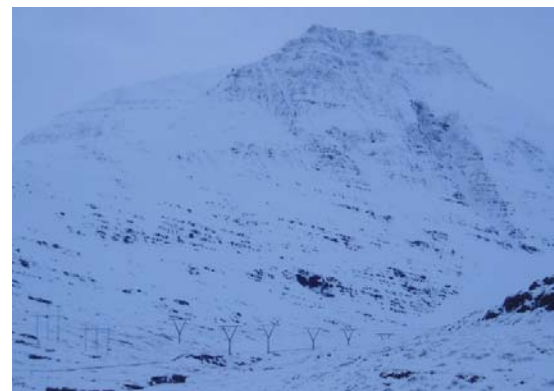
Figure 4. Typical avalanche terrain.

A 420kV line in northeastern Iceland (Jonsson, 2008) is the only source of electrical power to a large aluminum smelter. This line passes through approximately 50km of glaciated volcanic terrain in eastern Iceland. Lack of forest, strong winds, steep terrain and a high latitude maritime climate characterize avalanche conditions. The line elevation is between 20 and 620 meters above sea level. The design magnitude avalanche is associated with heavy precipitation and strong winds. Figure 4 shows typical avalanche terrain.

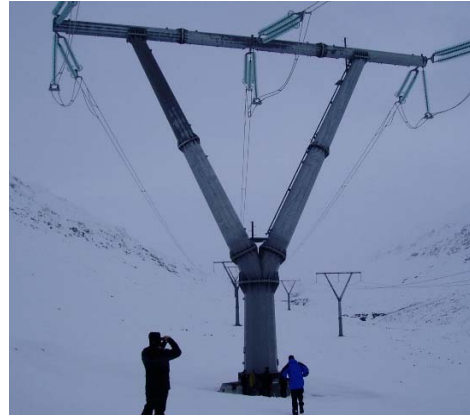
Figure 5. “Y” type Single Pole Tower

The Iceland transmission line has 82 structures that are exposed to some avalanche impact. Figure 5 shows the “Y” type single pole towers used in Iceland. Some of the conductors are exposed to low density portion of the upper avalanche flow, but these loads are relatively small due to the heights of the conductors. The annual probability, P , or return period $T (= 1/P)$ was calculated based on an analysis 50 years of weather data from four weather stations within the region. Statistical runout models and dynamic models were used to calculate design loads. Vegetative indicators are generally not available in Iceland. The calculated exposure level for failure of both lines was, $P = 6.5 \times 10^{-4}$ ($T \approx 1500$ years).

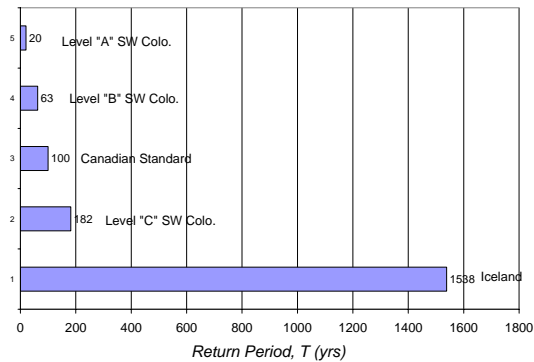
and the Iceland 420 kV line, along with the Canadian standard. The Colorado example is from a recreational area and has a redundant source of electrical power. Essential services may be maintained in case of failure in the 115kV line. In Iceland, the aluminum smelter is supplied by the 420kV line. Failure of the line over a period of more than a few hours would result in failure of the smelter and a loss of approximately \$US 1 billion. This is an unacceptable monetary loss.

Figure 6 Return Periods for Various Levels of Risk for Transmission Lines.

Figure 6 shows average return periods associated with acceptable levels of risk for the SW Colorado transmission line
